SUBJECT: August 2014 Inspection Report for the former Cornell Dubilier Electronics (CDE) Superfund Site, South Plainfield, New Jersey

LATA Project # 11266
Contract # W912DQ-09-D-3003,
Task Order # 0011

DATE: September 12, 2014

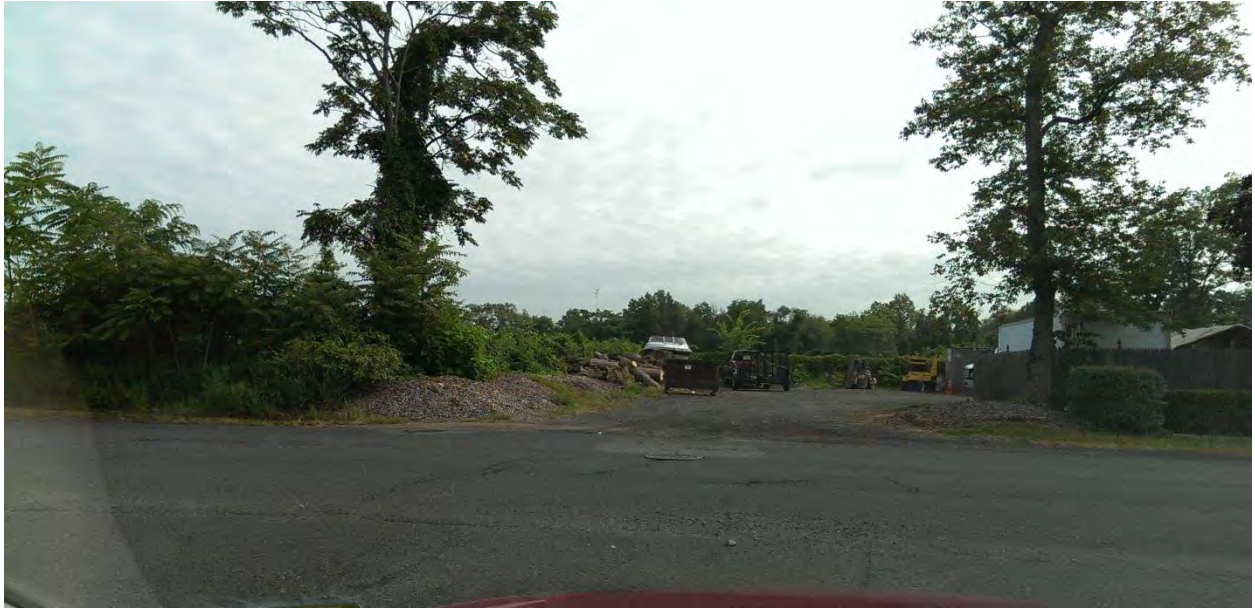
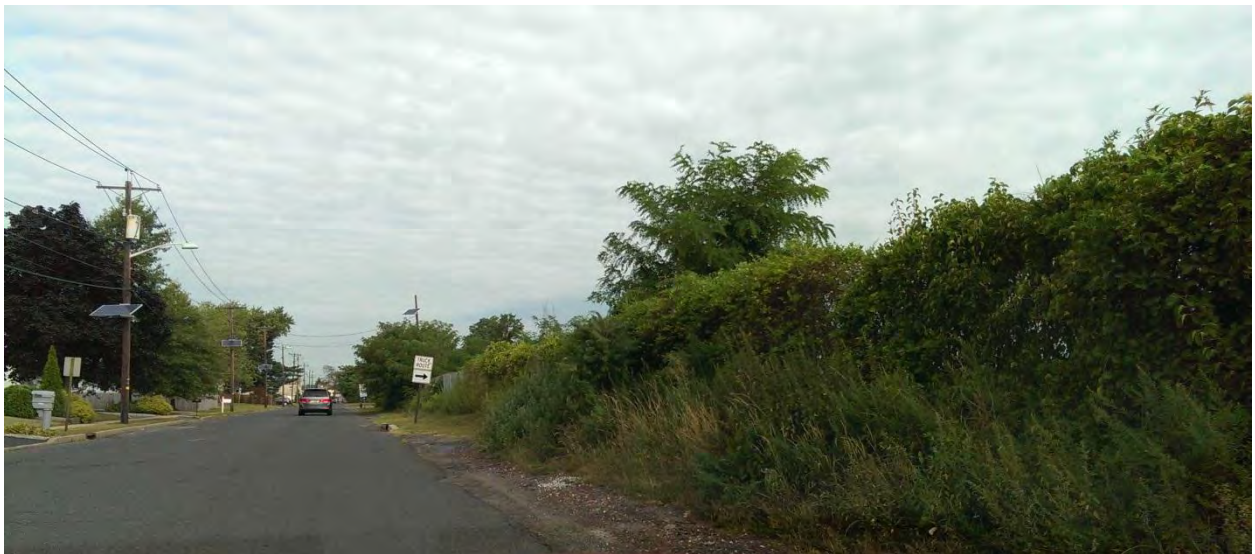
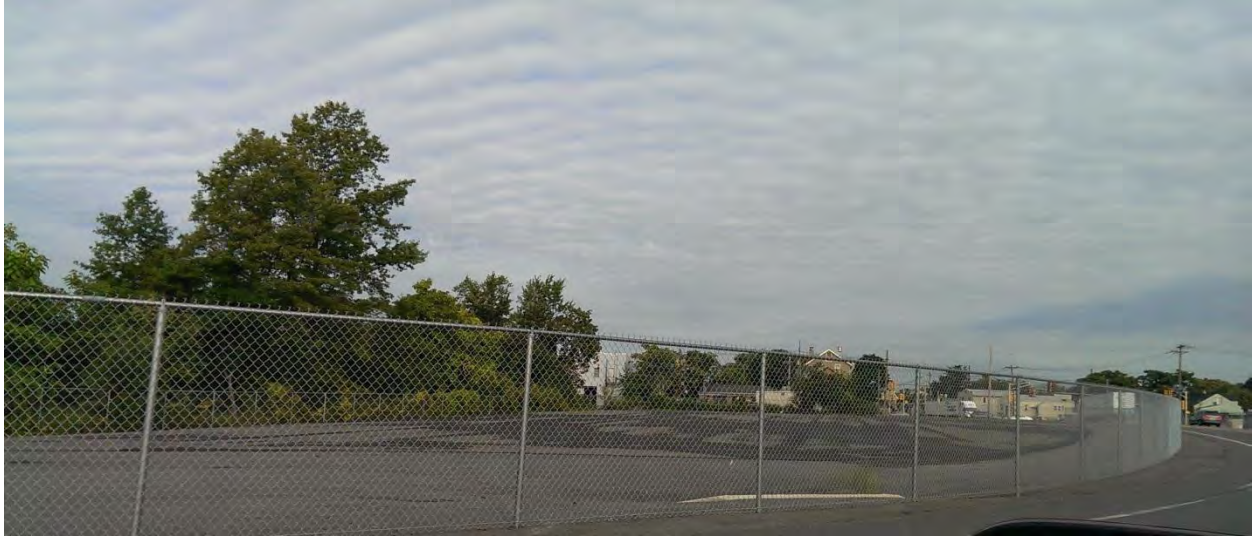
Fence drive by inspection photos

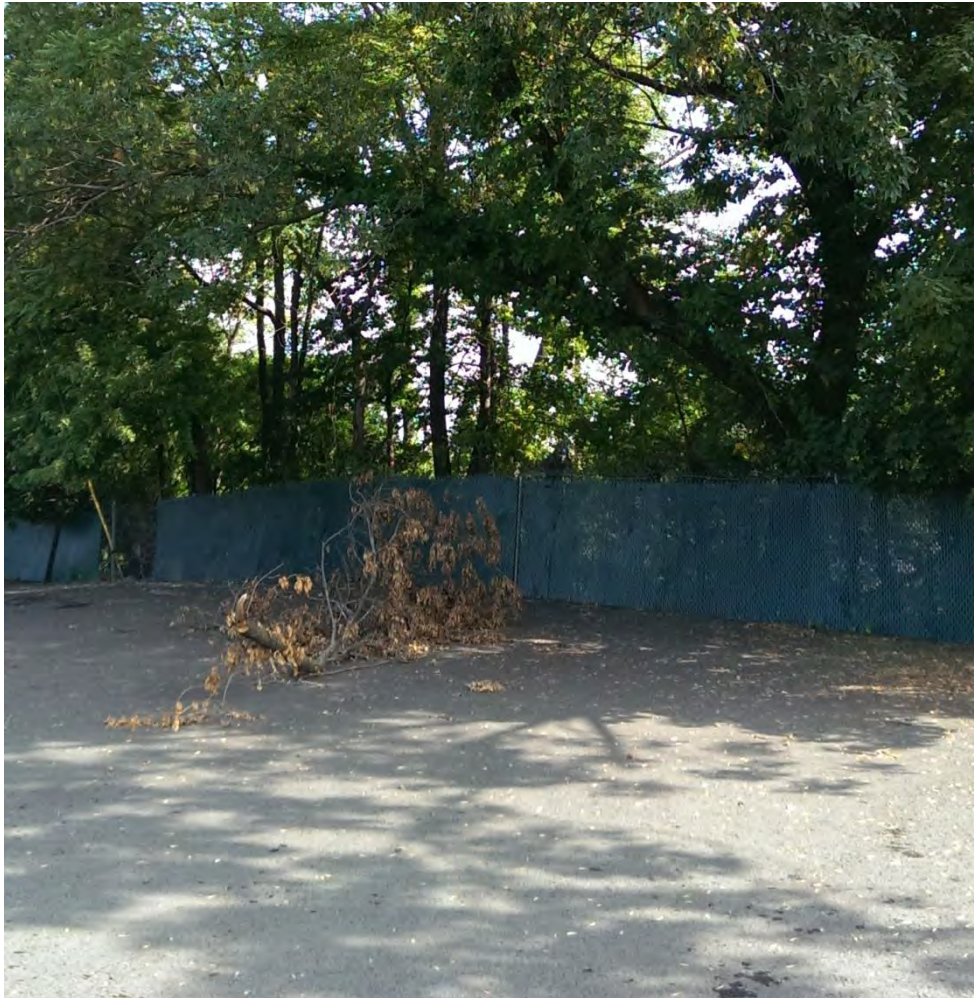
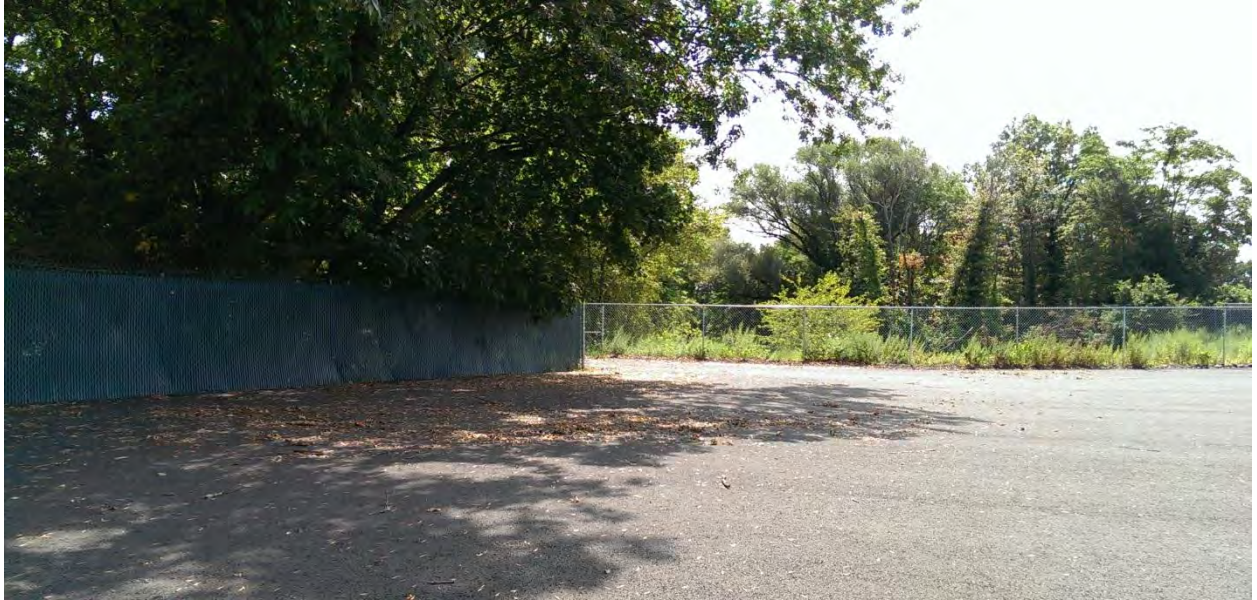
Broken/ fallen branch in water tower area removed from site.

Fallen branch (before / after)

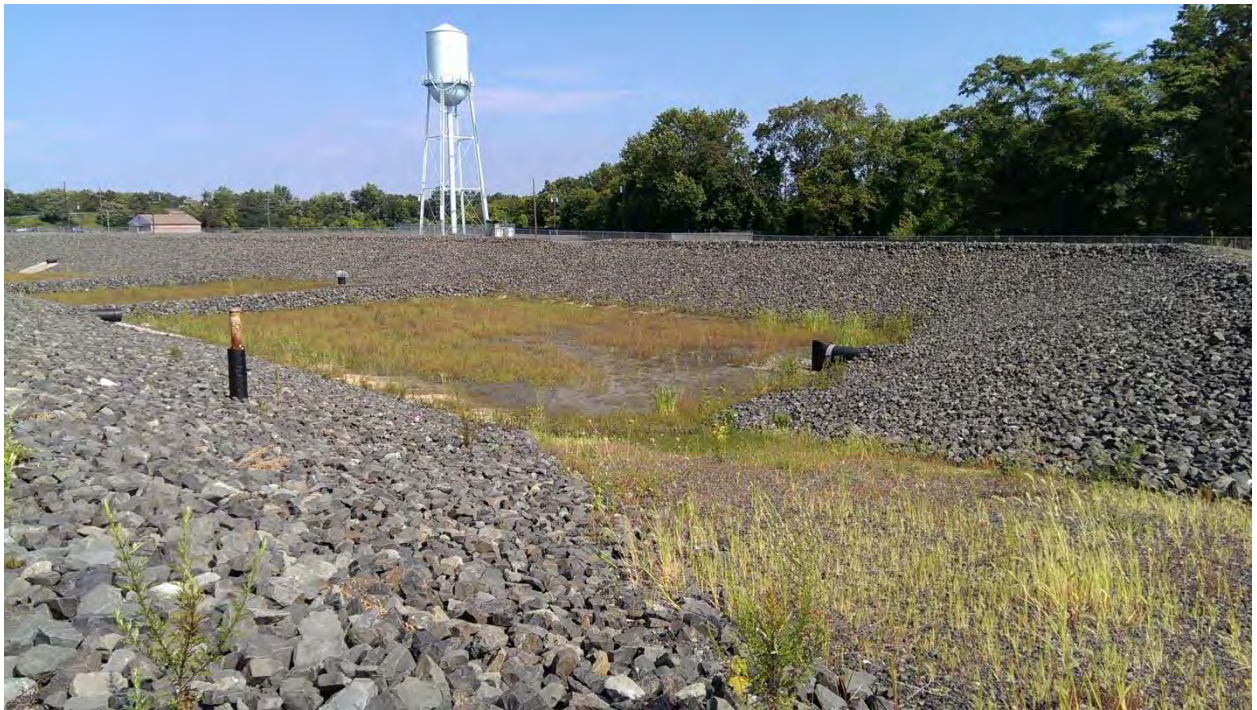
Detention basin, < 1" of water
